# Summary of Work

## Faith Haven Apartments

4901 Grand Avenue  
Duluth, MN

B/A project: 624-01

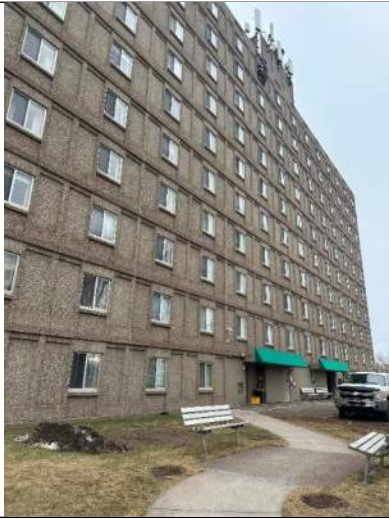
<b>Site</b>		
<p><b>Update accessible parking and accessible route.</b> Correct access aisle slope and eliminate trip hazards/offsets in concrete walks through jacking, grinding and/or replacement of sidewalks.</p>		 
<p><b>Selective regrading around buildings for proper drainage.</b> Water intrusion occurring in heavy rain events at foundation due to site drainage issues and lower entrance doors/paving.</p>		 
<b>Building Envelope</b>		
<p><b>Existing windows</b> leak at perimeter and at sash in heavy rain events leading to water intrusion into interior wall assemblies</p>

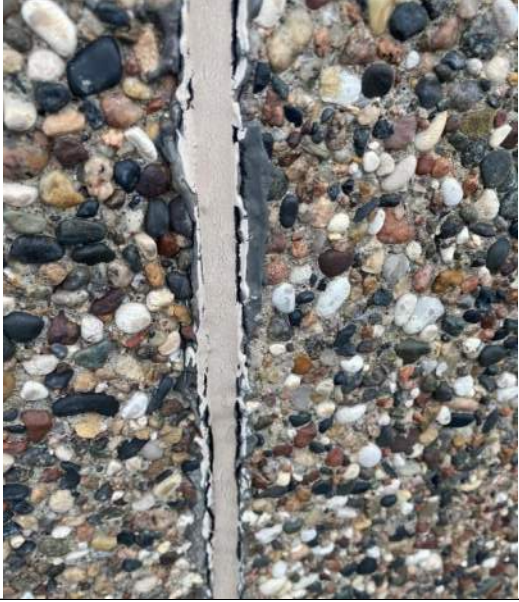
<p><b>Existing sealants</b> at exterior wall panels are beyond useful life with cracks and gaps leading to water intrusion and potential mold growth in unit walls</p>

1. Replace roofing: new fully adhered EPDM, reusing existing insulation in good condition.
2. Replace windows: new fiberglass windows at existing openings throughout (Critical Need).
3. Replace caulking at building exterior panel joints, typical at all facades/all levels (Critical Need).
4. Replace canvas awnings with new canvas awnings.

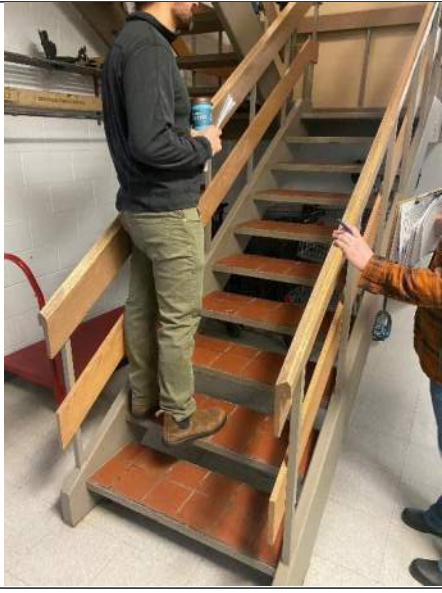
<b>Interior Common</b>		
<p><b>Existing main lobby stair</b> represents trip and fall hazard. Stair to lower level is non-compliant with open risers and baluster spacing exceeding code requirements</p>

1. Interior finishes: new flooring and paint at all common areas and corridors.
2. Replace 50% of handrails at corridors.
3. Replace 25% of common areas doors
4. Reconfigure common laundry room, provide new appliances.
5. Construct new mail room for accessibility and compliant USPS 4c boxes.
6. Renovate existing common area restrooms on lower level to create 3 new single user restrooms.
7. Close risers and replace guardrail at lobby stair to lower level (Critical Need).

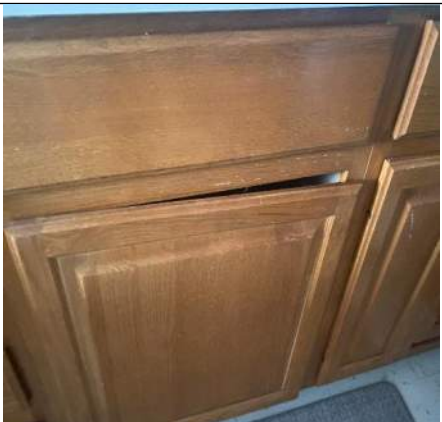
<b>Units</b>		
<p><b>Plumbing stack replacement</b> requires removal and replacement of kitchen cabinets and counters.</p>

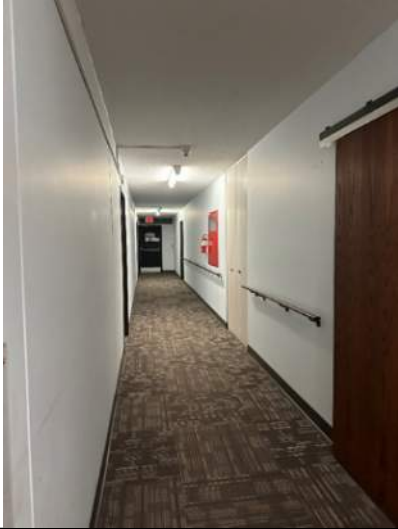
<b>Mechanical and Electrical Systems</b>		
<p><b>Non sprinklered high-rise</b> building is non code compliant. Extend system to common areas, corridors, and units for compliance.</p>

1. Add sprinkler system throughout building. (Critical Need).
  - a. Existing sprinkler at mechanical / trash areas only – extend wet pipe system throughout.
  - b. Add electric heaters at building stairwells where sprinkler coverage required to prevent freezing.
  - c. Revise water service to building to accommodate additional demand.
2. Replace waste and vent plumbing stacks (Critical Need).
3. Replace domestic water plumbing stacks.
4. Upgrade/replace firestopping at building plumbing/vent stacks. (Critical Need).
5. Replace plumbing fixtures (low flow Watersense fixtures) – see units.
6. Replace rooftop ventilation (PRV) components.

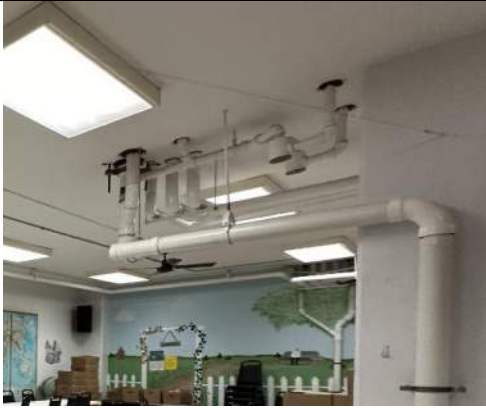
<p><b>Cast iron drain waste and vent piping exhibits systematic failure</b> with cracks and leaks in mains, and short term repairs.</p>

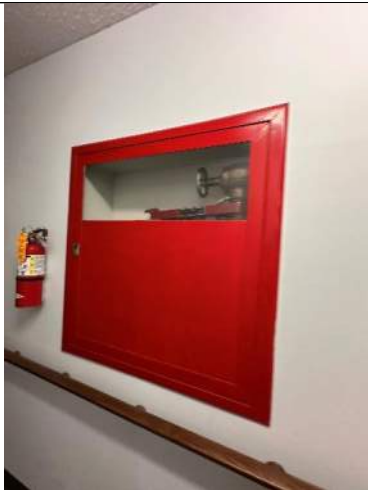
<p><b>Fire alarm system requires update</b> for compliance and AHJ approvals, remove non-compliant hose cabinets.</p>

1. Replace unit light fixtures with LED fixtures
2. Replace common area light fixtures with LED fixtures
3. New smoke detectors in common and in units – see Units
4. New thermostats.
5. Update fire alarm system (Critical Need).
6. Supplemental electric heaters at stairwells where sprinkler coverage is required at non-conditioned areas.
7. New 85 kw emergency power generator and connect elevator to circuit. (Critical Need).
